# LMT-MERCER GROUP, INC. TEST REPORT

ICC-ES AC273 TESTING ON 1-1/2 IN DIAMETER ALUMINUM HANDRAIL

H3133.01-119-19 R0

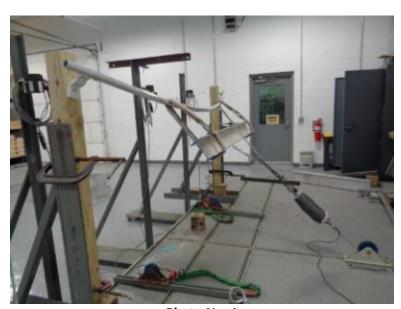
Photo No. 1
Uniform Load Test Applied at 45 degrees

Design Load: 50 lb / ft Uniform Load applied at 45 degrees on Top Rail

LOAD LEVEL	TEST LOAD (lb)	E.T. (min:sec)	RESULT
1000 lb (2.50 x D.L.)	1000 - 1008	01:35 - 02:40	Sustained load equal to or greater than 1000 lb for one full minute without failure

LOAD LEVEL	TEST LOAD (lb)	E.T. (min:sec)	RESULT
1000 lb (2.50 x D.L.)	1000 - 1009	01:20 - 02:25	Sustained load equal to or greater than 1000 lb for one full minute without failure

LOAD LEVEL	TEST LOAD (lb)	E.T. (min:sec)	RESULT
1000 lb (2.50 x D.L.)	1000 - 1009	01:06 - 02:09	Sustained load equal to or greater than 1000 lb for one full minute without failure

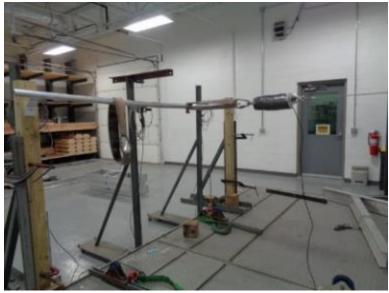
Photo No. 2
Horizontal Concentrated Load Test at Mid-Span of Handrail

Design Load: 200 lb Horizontal Concentrated Load at Mid-Span of Top Rail

LOAD LEVEL	LOAD LEVEL TEST LOAD	E.T. (min:sec)	DISPLACEMENT (in)			
LOAD LEVEL	(lb)		END	MID	END	NET <sup>1</sup>
200 lb (D.L.)	200	00:37	0.23	1.96	0.22	1.74
500 lb (2.50 x D.L.)	501 - 505	01:06 - 02:09		thstood load o for one full	•	•

LOAD LEVEL	TEST LOAD	E.T. (min:sec)	DISPLACEMENT (in)			
LOAD LEVEL	(lb)		END	MID	END	NET 1
200 lb (D.L.)	201	00:31	0.18	2.08	0.22	1.88
500 lb (2.50 x D.L.)	502 - 507	01:03 - 02:07			l equal to or minute with	•

LOADIEVE	D LEVEL TEST LOAD (Ib) E.T. (min:sec)	E.T.	DISPLACEMENT (in)			
LOAD LEVEL		(min:sec)	END	MID	END	NET <sup>1</sup>
200 lb (D.L.)	201	00:28	0.34	1.96	0.48	1.55
500 lb (2.50 x D.L.)	501 - 510	00:58 - 02:01	<b>Result</b> : Withstood load equal to or great than 500 lb for one full minute without failure		•

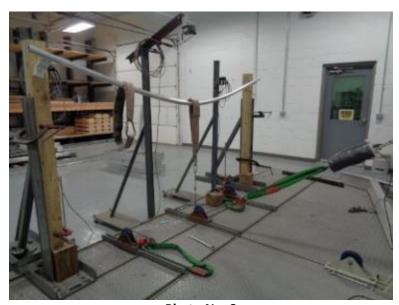
Photo No. 3
Vertical Concentrated Load Test at Mid-Span of Handrail

Design Load: 200 lb Vertical Concentrated Load at Mid-Span of Top Rail

LOAD LEVEL TEST LOAD	E.T.	DISPLACEMENT (in)				
LOAD LEVEL	(lb)	(min:sec)	END	MID	END	NET 1
200 lb (D.L.)	200	00:54	0.08	2.56	0.08	2.48
500 lb (2.50 x D.L.)	501 - 508	01:40 - 02:45			l equal to or I minute with	•

LOAD LEVEL TEST LOAD	E.T.	DISPLACEMENT (in)				
LOAD LEVEL	(lb)	(min:sec)	END	MID	END	NET <sup>1</sup>
200 lb (D.L.)	200	00:34	0.04	2.38	0.06	2.33
500 lb (2.50 x D.L.)	502 - 510	01:28 - 02:29			l equal to or minute with	•

LOAD LEVEL	TEST LOAD	E.T. (min:sec)	DISPLACEMENT (in)			
LOAD LEVEL	(lb)		END	MID	END	NET <sup>1</sup>
200 lb (D.L.)	200	00:34	0.03	2.39	0.08	2.34
500 lb (2.50 x D.L.)	501 - 514	01:16 - 02:19	<b>Result</b> : Withstood load equal to or greate than 500 lb for one full minute without failure		•

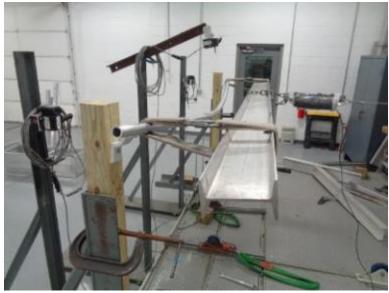
Photo No. 4
Horizontal Concentrated Load Test at Ends of Handrail (Brackets)

Design Load: 200 lb Horizontal Concentrated Load at Ends of Rail (Brackets)

LOAD LEVEL 1	TEST LOAD (lb)	E.T. (min:sec)	DISPLACEMENT (in)
1000 lb (2.50 x D.L.) x 2	1001 - 1010	01:03 - 02:08	<b>Result</b> : Each end withstood load equal to or greater than 500 lb for one full minute without failure

$<sup>^{1}</sup>$ A spreader beam was used to impose loads on both ends of the rail, therefore loads were doubled.

LOAD LEVEL 1	TEST LOAD (lb)	E.T. (min:sec)	DISPLACEMENT (in)
1000 lb (2.50 x D.L.) x 2	1001 - 1013	00:45 - 01:57	<b>Result</b> : Each end withstood load equal to or greater than 500 lb for one full minute without failure

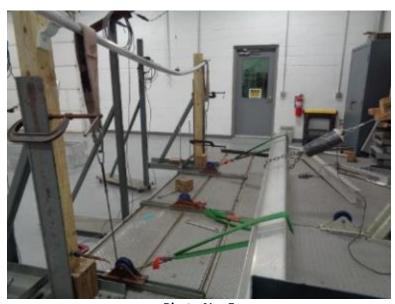
Photo No. 5
Vertical Concentrated Load Test at Ends of Handrail (Brackets)

Design Load: 200 lb Vertical Concentrated Load at Ends of Rail (Brackets)

LOAD LEVEL <sup>1</sup>	TEST LOAD (lb)	E.T. (min:sec)	DISPLACEMENT (in)
1000 lb (2.50 x D.L.) x 2	1000 - 1025	01:55 - 02:58	<b>Result</b> : Each end withstood load equal to or greater than 500 lb for one full minute without failure

<sup>&</sup>lt;sup>1</sup>A spreader beam was used to impose loads on both ends of the rail, therefore loads were doubled.

LOAD LEVEL <sup>1</sup>	TEST LOAD (lb)	E.T. (min:sec)	DISPLACEMENT (in)
1000 lb (2.50 x D.L.) x 2	1001 - 1022	01:09 - 02:16	<b>Result</b> : Each end withstood load equal to or greater than 500 lb for one full minute without failure

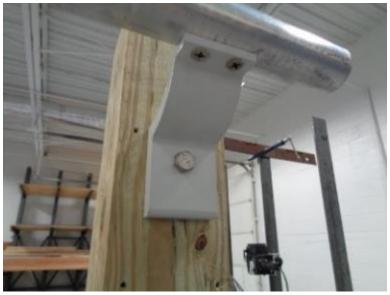
Photo No. 6
Handrail Bracket Connection

CONNECTION	FASTENER
Bracket to Post <sup>1</sup>	One 3/8 in by 3 in (0.267 in minor diameter) 7 TPI, stainless
	steel, hex-head lag bolt
Bracket to Rail <sup>2</sup>	Two ¼ in by 1 in (0.183 in minor diameter) 14 TPI, stainless steel,
	flat-head, Philips drive screws

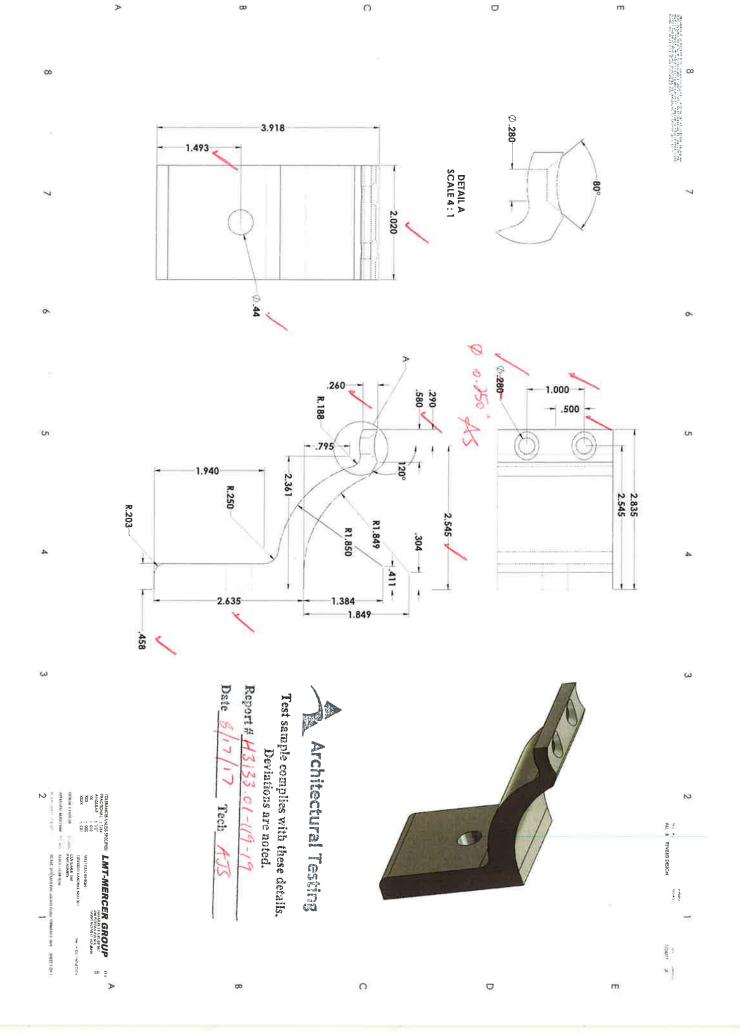
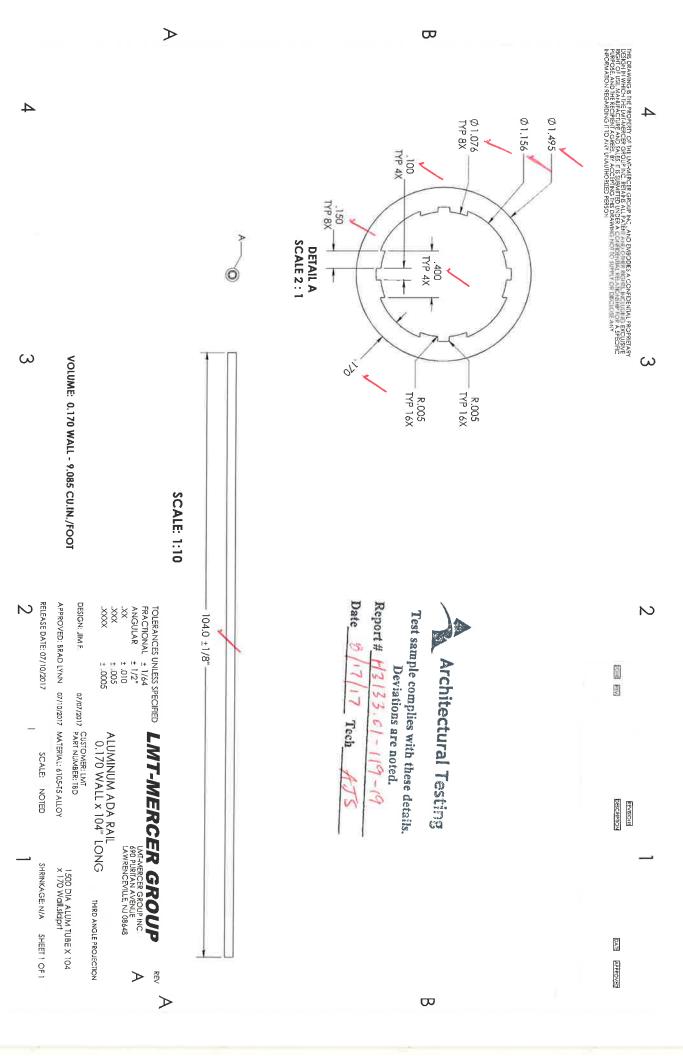
The "As-Built" drawings for the 1-1/2 in aluminum handrail, which follow, have been reviewed by Intertek B&C and are representative of the project reported herein. Project construction was verified by Intertek B&C per the drawings included in this report. Any deviations are documented herein or on the drawings.

SERIES/MODEL	Aluminum handrail system
HANDRAIL	1-1/2 in diameter (OD) by 0.17 in. wall by 104 in long (overall)
	6105-T5 extruded aluminum
HANDRAIL ATTACHMENT	2 in wide 6063-T5 die cast aluminum brackets spaced 96 in on-
	center
POST	4 by 4, preservative treated Southern Yellow Pine posts
