MOCK-UP DESCRIPTION

DYNAMIC WIND LOADING ON OZ-POST SUPPORT
OZ-POST™, INTERNATIONAL
Test Report #CCLI-07-046

1. POST ASSEMBLY DESCRIPTION

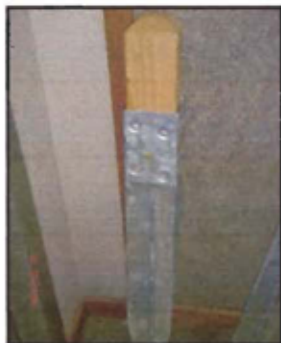
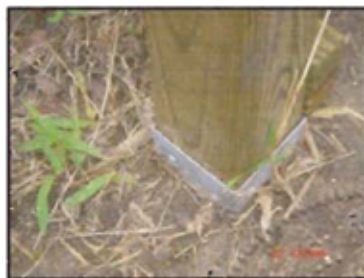
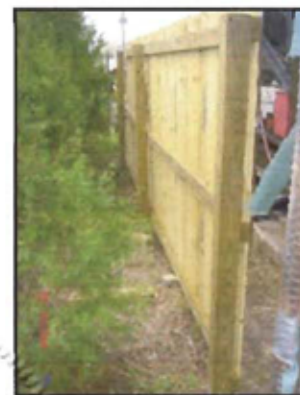
GENERAL DESCRIPTION: Oz-PostTM, International T-4 850 Oz-PostTM Support was subjected to dynamic wind loading to simulate a hurricane force wind on a fence. The specimen's tested overall size is 16'-0" x 6'-0". The first specimen consisted of five (5) T-4 850 Oz-PostTM Supports spaced 4' apart with an embedment of 32". The second specimen consisted of three (3) T-4 850 Oz-PostTM Supports spaced 8' apart with an embedment of 32". A Pressure Treated Southern Yellow Pine 4" x 4" was then slipped into an Oz-PostTM support and attached with two (2) #10 x 1½" screws at each side of the post, total of eight (8) screws. Pressure Treated Southern Yellow Pine 2" x 4" rails are attached to the post with 10d nails, three per connection. 1" x 6" planks attached to the rails with 6d nails, two (2) per rail, total of six (6) nails.

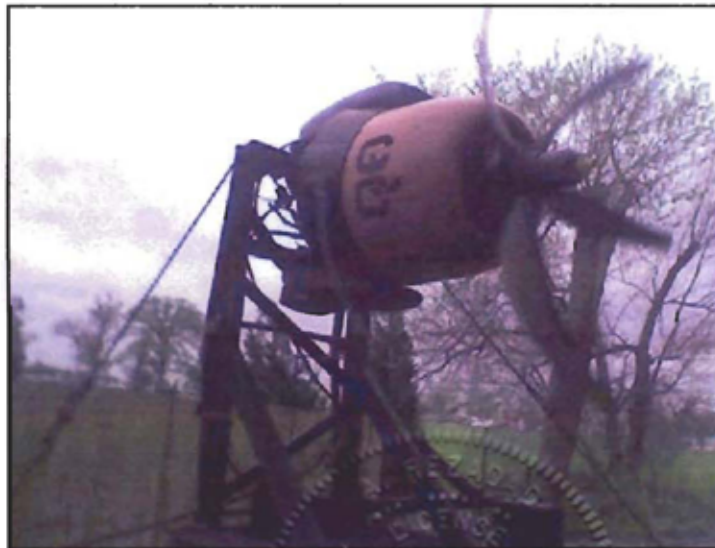
Test @ 120 Mph, 16'-0" x 6'-0" test specimen, Oz-Post™ Support spaced 4 feet on center.

5-Minute Test Results: The fencing along with the Oz-Post™ remained fully embedded in the soil. There was no visible damage and no separation of the wood posts to the Oz-Post™ supports during the test. At test conclusion, there was a permanent set of 1" at the top mid-span of fence. Rocking the fence back and forth at test conclusion resulted in an observed ¾" movement of the Oz-Post™ in the surrounding soil.

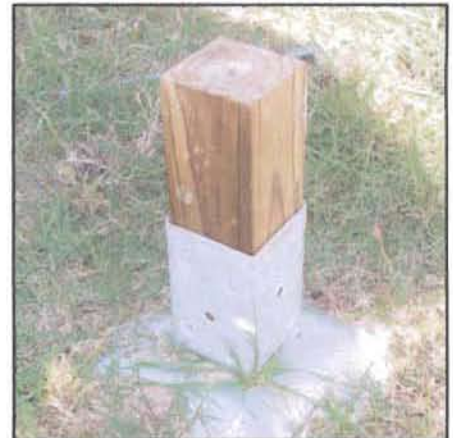
The post assembly consisted of the Oz-Post™, International T-4 850 Oz-Post™ and OD-T-4 Oz-Deck Deck Plate. The T-4 850 Oz-post inserts through cross-slots in the OD-T-4 Deck plate and as a post assembly was driven into a native North Texas regional soil using an Oz-post designed pneumatic jackhammer. The soil characteristics such as moisture content, void ratio and other parameters were not known at the time of testing. Upon contact between the deck plate and the soil, the hammer was allowed to dwell on the post for a period between 1-2 minutes to seat the plate onto the soil.

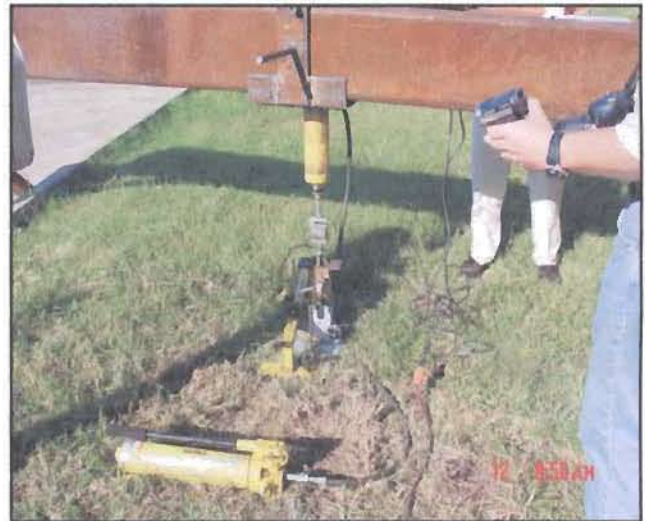
The downward compressive test load was applied with an Enerpac hydraulic ram and cylinder. The test load was measured with an Omega S-Type load cell and indicated with an Omega digital indicator, Calibration Date effective till August, 2008 by Nicol Scales. The hydraulic cylinder was mechanically attached to a steel tube fixture with the ram and load cell aligned directly above the post assembly. Chicago dial indicators with maximum movement indicator arms were positioned on the test fixture, deck plate and the deck post to measure the amount of movement during the compression loading.

The Oz-PostTM post assembly resisted the above reported loads with no visible damage to the post or plate. The minimum load of 1800 Lbs. requested by Oz-Post was to evaluate the post assembly under a 50psf total uniform load over a 36ft² tributary area based upon a 6'-0" post spacing. The loads listed in section 4 would be the total load resisted. The reported loads results could vary dependent on deck design and construction and soil type which are the responsibility of the end user of this product.
