Project 110 Estate Wooden Mailbox Post Assembly

V1.00 - Installation Instructions effective May 1, 2015 and reflects information that available as of April 10, 2014. This information is updated periodically and should not be relied upon after May 1, 2015. Please visit www.OZCOBP.com to get current information

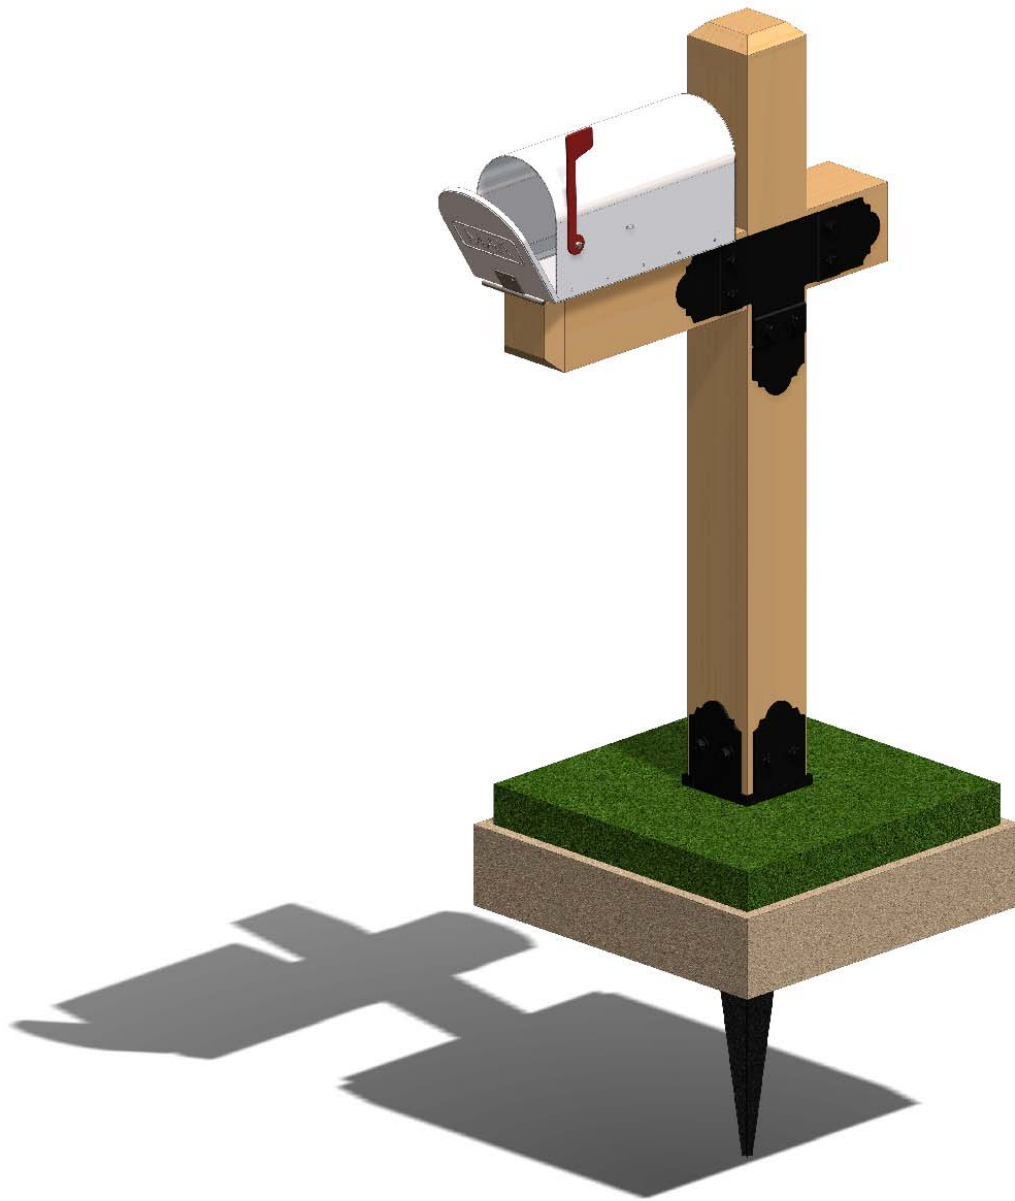
for Post Anchor,
see Installation
Instructions,
56632-34

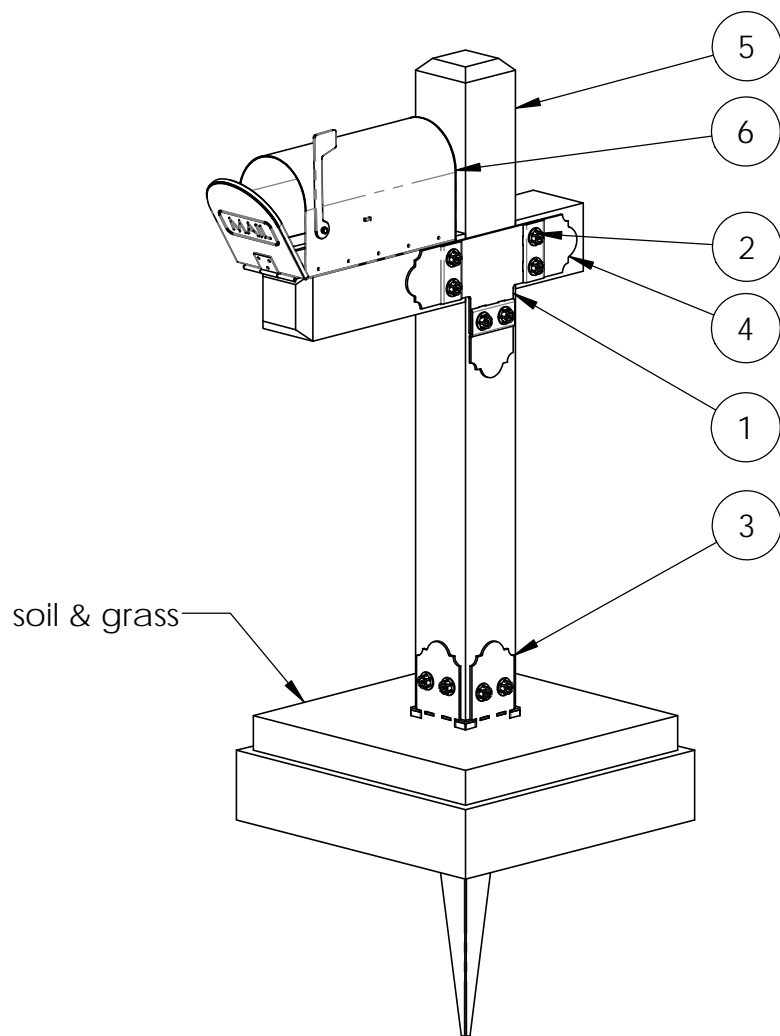
Bill of Materials

ITEM NO.	QTY.	PART NUMBER	DESCRIPTION
1	1	56612	T Tie Plate
2	1	56626	OWT Timber Screw 2-3/4"
3	1	56633	Assembly, 6x6 Post Anchor
4	3	56611	Truss Accent
5	1	6x6x8	6x6 Cedar Post
6	1	mailbox

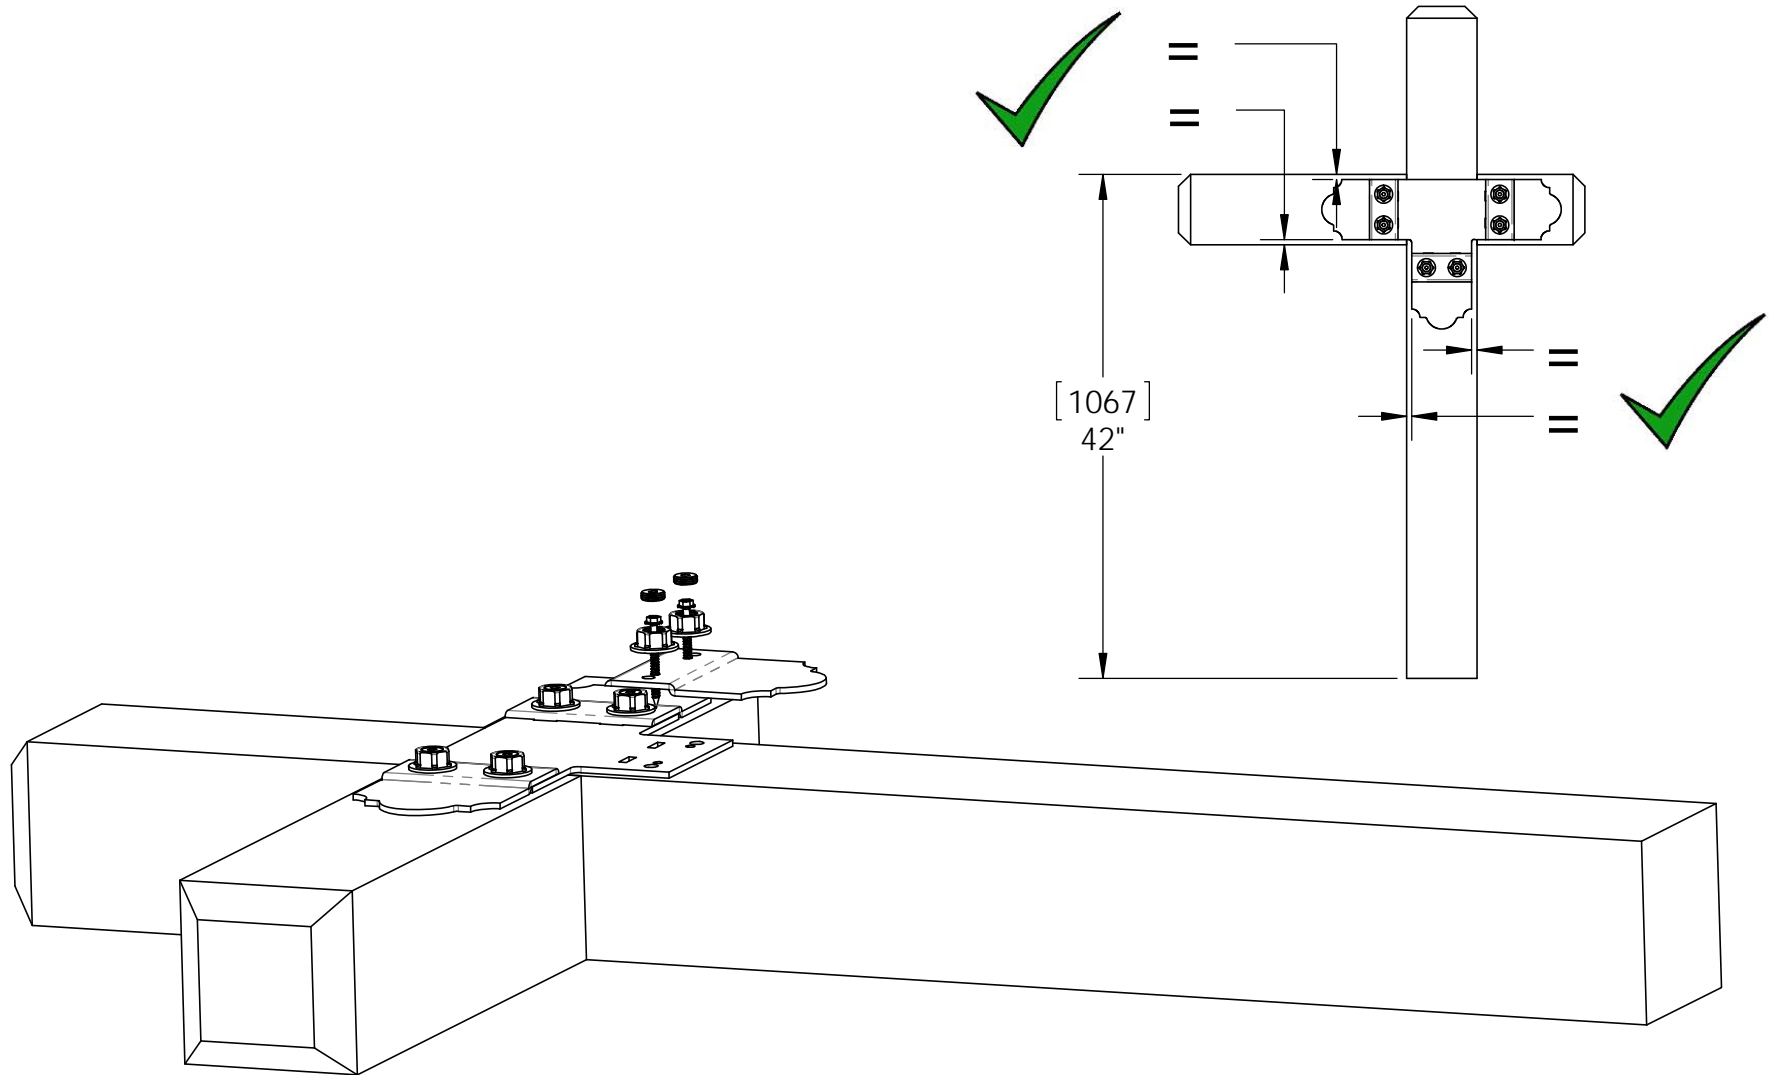
step 1

assemble on flat non-marring surface

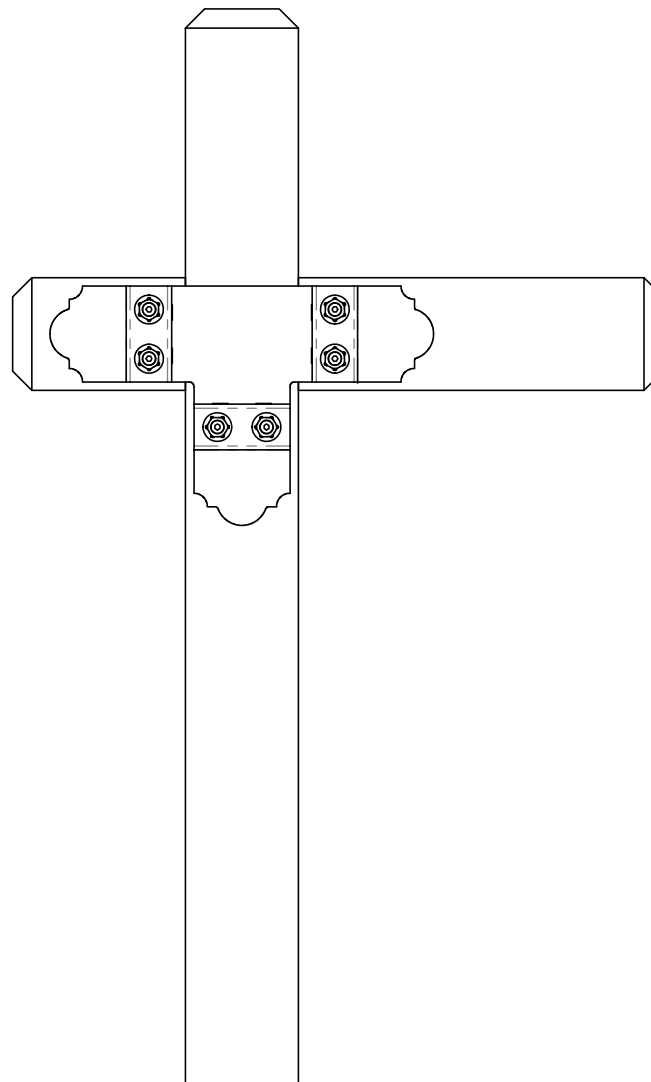
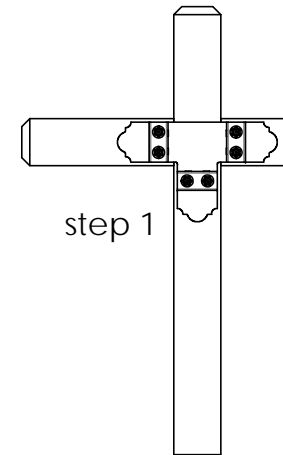
step 2
repeat step 1 on opposite side

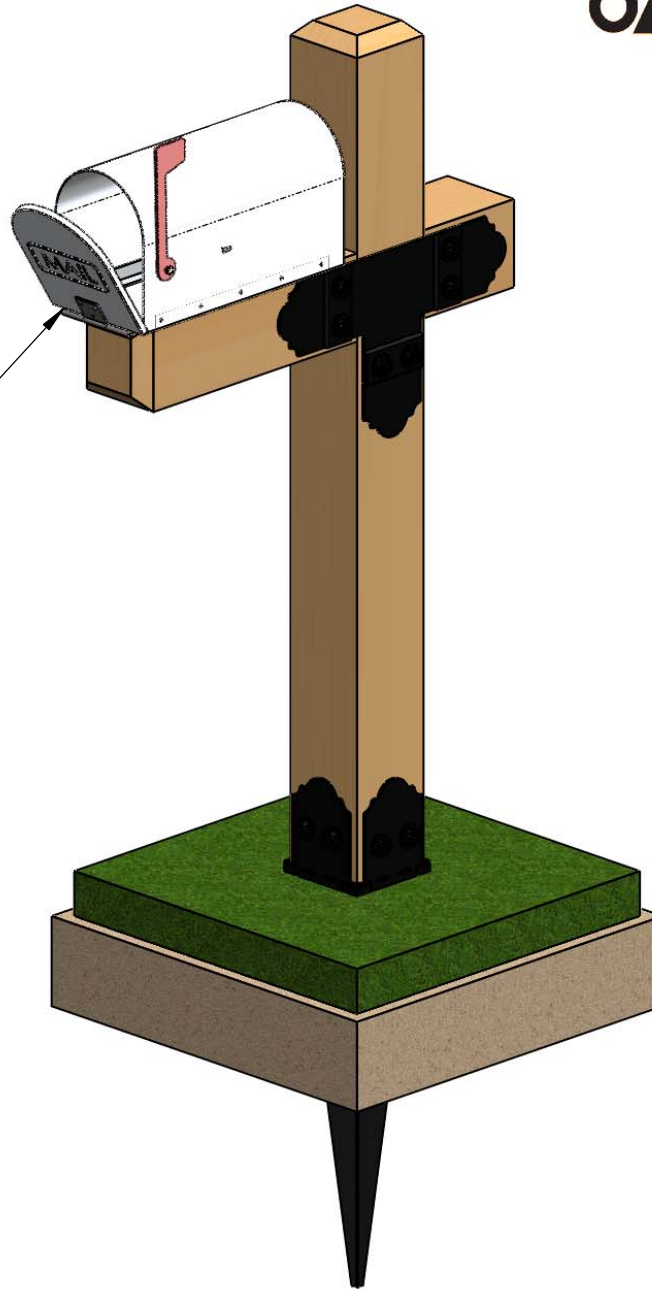
step 4

install mailbox per
manufacturers instructions
